Subject: Emergency Repair of Moss Landing Road Flap Gates and Culverts

Subject: Emergency Inspection and Repair of Moss Landing Road Flap Gates and Culverts

SITE VISIT REPORT-DIVE

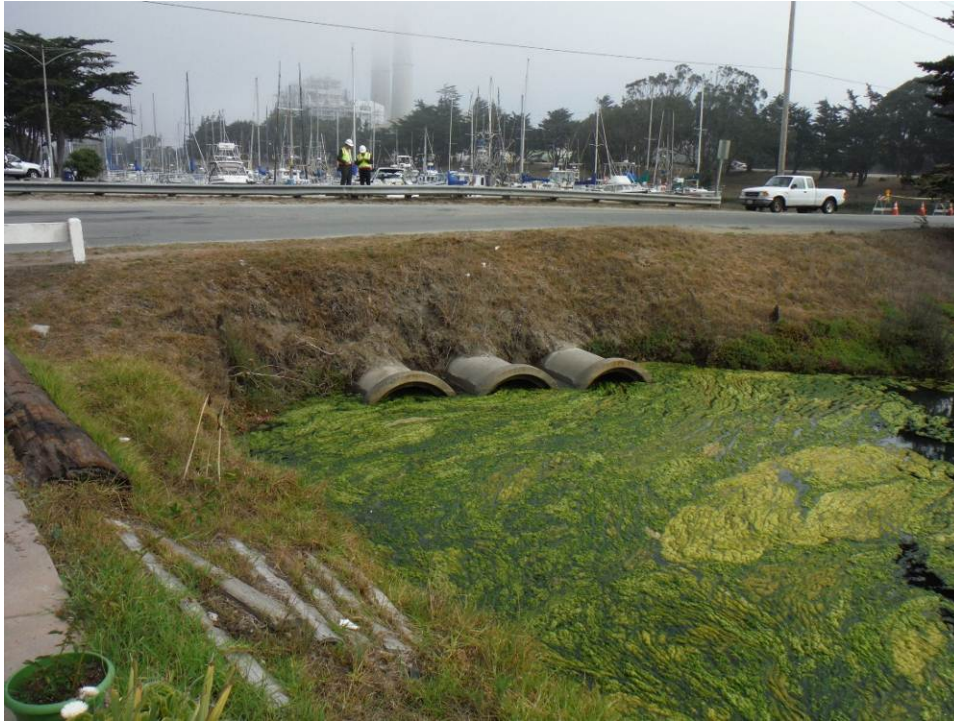
Figure 2. Culvert Inlets on Moro Cojo Slough (5.8 ft high tide October 8, 2014)

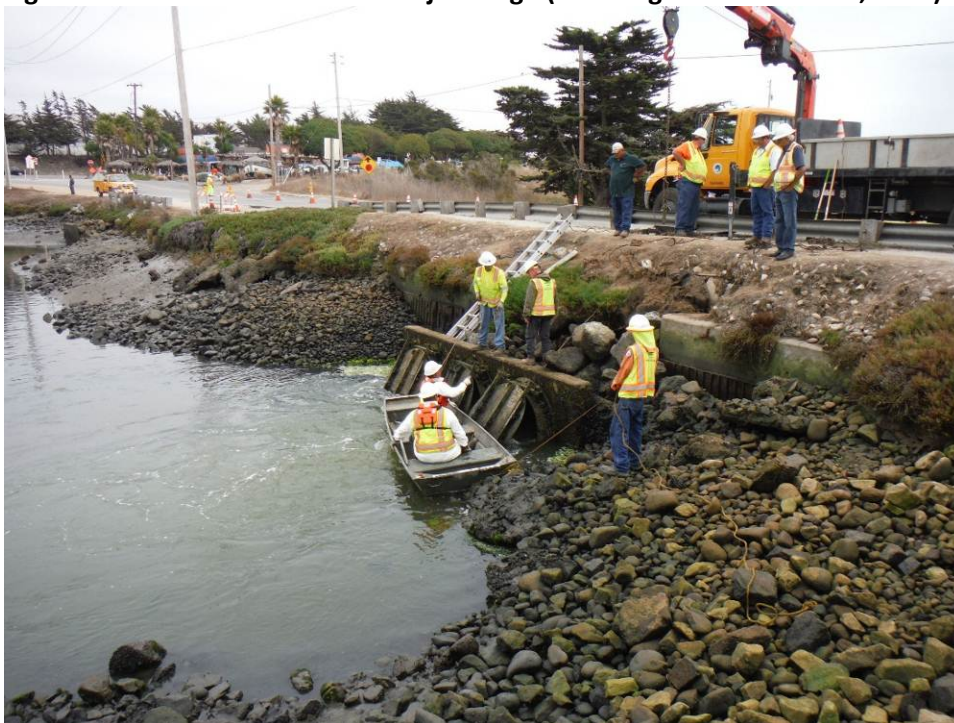
MCRMA performed some initial investigations that included placing a video camera in the pipes at low tide on October 9. The video shows that the culvert is severely degraded in some areas, which may compromise the ability of the system to function properly. There is strong visual evidence that seawater is traveling into the pipe system in a manner that was not designed for with the resulting effect of loss of supporting soil in the area adjacent to the pipes.

Figure 3. Culvert Outlets and Flap Gates; Initial Investigation with video camera in pipe (low tide 5pm October 9, 2014).

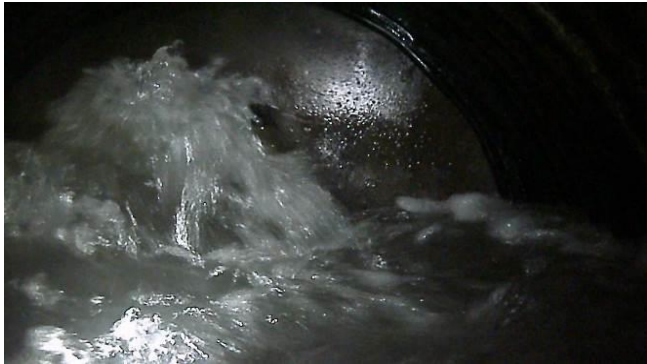
Item	Photo/Video
<p>1. Performed 3 dives into the pipes to observe source of leakage, and measure joint openings in pipes</p> <p>Dive 1: 12:35 pm start (4.0 ft tide)-initial observations into Pipe 1,2,3</p> <p>Dive 2: 1:30 pm start (3.7 ft tide)-Took video and measured pipe 1 joint separations</p> <p>Dive 3 4:15 pm start (0.3 ft tide) Measured Pipe s 2,3 joint separations</p> <p>Low Tide (5pm) waded on outside of gates from shore to feel bottom of gates to confirm holes in throat of gate.</p> <p>2. Pipe #1 (see figure 1 attached) observed strong vertical gushing of water inside of pipe at tide gate on inside of pipe. Felt hole in bottom of tide gate throat. 4 ft differential head at time. This is the main source or leakage and the ripples seen from the slough side of the pipe.</p>

<p>1. Pipe 1 vertical gushing water behind gate</p>

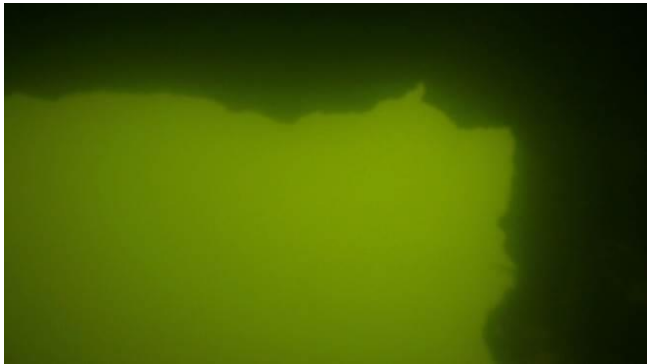
<p>2. Pipe 1, right side of Hole in throat of gate</p>

The two leaking gates will be repaired by welding new stainless steel patches to the damaged areas. The gates will then be brought back to the site within a few days at a low tide. The blind flanges will be removed and the repaired gates bolted back into place and the culvert restored to their original functional condition. During the repair of the two leaking gates, the third tide gate will still be operational.

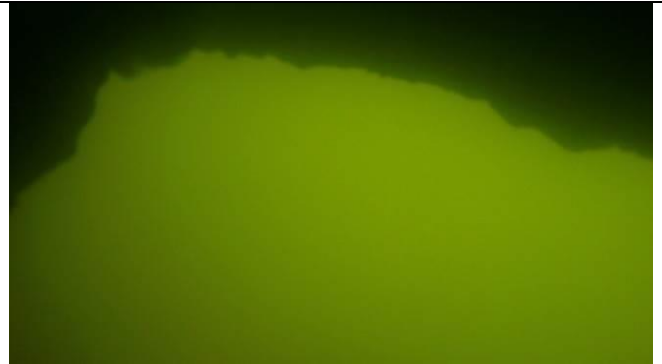
3.-Pipe 1-Left side of Hole in throat of gate

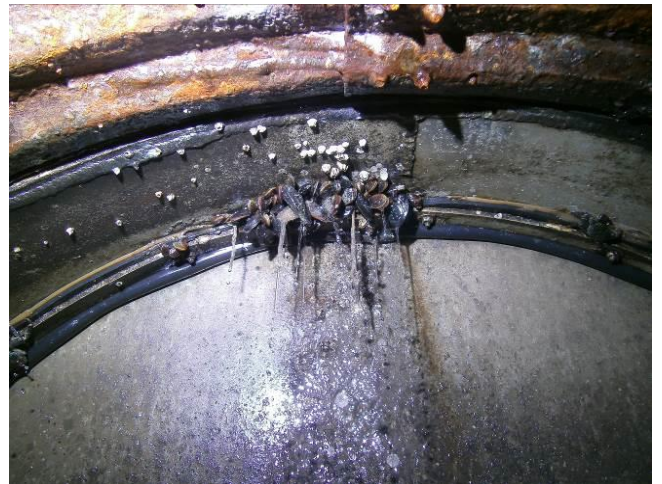
4. Pipe 3-Observed minor leakage at top of gate from gasket, appears to be from mussels in fouling the seal to the joint.

8. Pipe 3-Leakage from gasket, mussel fouling

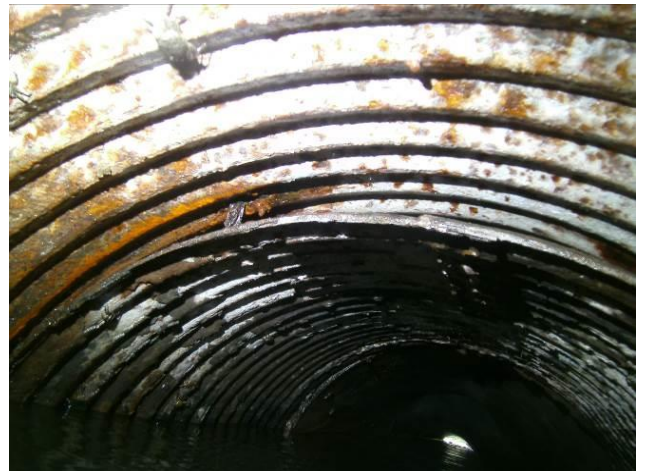
5. Pipe 3- At CMP joints to RCP observed not leakage. Observed some leakage in Pipes 2 and 3 at this joint and section of the pipe.

9. Pipe 3 CMP joints to RCP pipe, no leakage observed

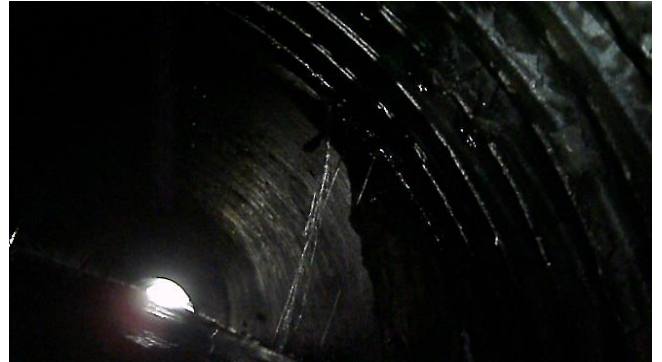
10. CMP to RCP joint in Pipe 1, minor leakage

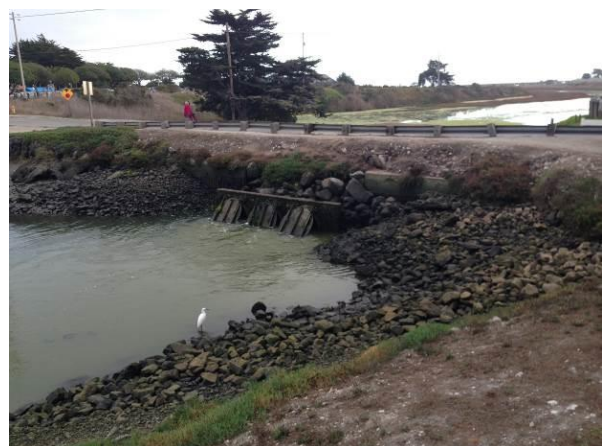
6. At low tide waded from harbor side outside of tide gates and was able to feel hole in bottom of gates 1 and 2.

12. Tide Gates at Low Tide (5:40 pm)
