Riparian Restoration on California's Coast

November 3, 2005

Installation of Large Wood Habitat Structures at the deDampierre Restoration Project

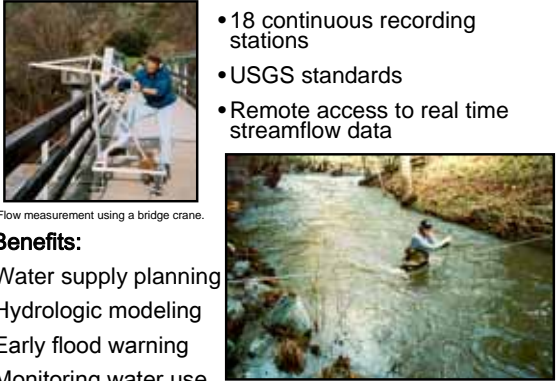
Streamflow Monitoring

- 18 continuous recording stations
- USGS standards
- Remote access to real time streamflow data

Flow measurement using a bridge crane.

Measuring flow with wading rod and current meter.

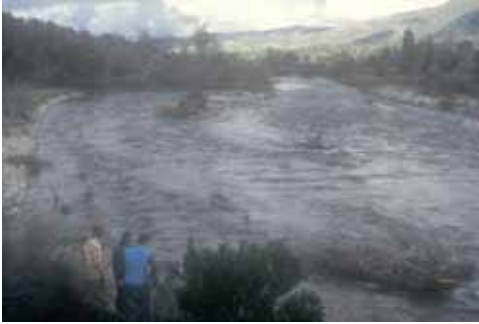
Reworking floodplain deposits

February 1995

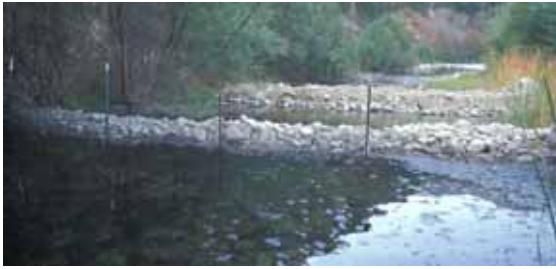
TEMPORARY ROCK DIVERSION DAMS

The low rock dam in the foreground, made of clean cobble and boulders found on site, prevents fish from entering a diversion channel (between the two dams), but allows algae and moss to pass through. A second dam, made from finer material found on site, diverts most of the flow from the main stem into the diversion channel. Flows ranged from about 5 to 8 cubic feet per second (cfs) during construction. Six fish were relocated out of the diversion at the end of the project.

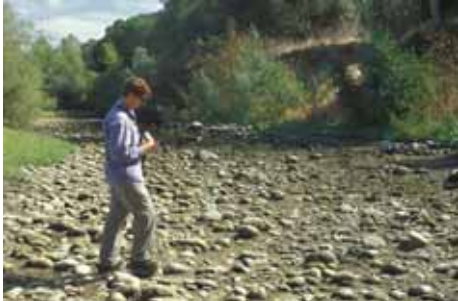
AFTER DIVERSION

Before construction of a diversion, flow covered the cobbles up to the grass seen to the left of Thomas Christensen (examining the underside of one of the cobbles). Main stem surface flow ceased completely 2,000 feet downstream (flow went subsurface), which reduced concerns about sediment impacts from construction. By diverting flow, the contractor was able to pump subsurface water out of construction areas.

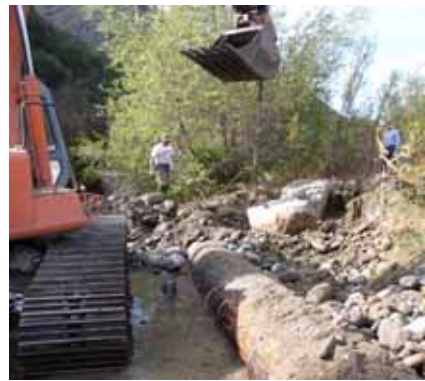
PLACING BOULDERS

Four to six-ton boulders were individually surveyed into place to provide a line of support and to anchor the logs. Here, the excavator is moving a boulder by hooking on to one of the four 3/4-inch cable anchors inserted in each rock.

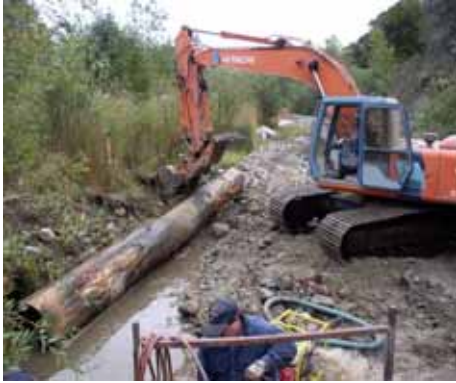
SETTING FOOTER LOG

A footer log was installed to encourage scour along the toe of the streambank. Although not visible in this photo, the footer log is anchored with four large boulders similar to the ones shown in the previous photo. Willow cuttings placed behind the footer log will be protected from scour during high flows.

Setting an eight-ton log and rootball in the right place requires experience and patience. Here, Gerry Paddock, the owner of Carmel Valley Construction, deftly places a 38-foot long log and rootball on top of four boulders. The log was placed at a 30 degree horizontal angle to flow. The log was also angled vertically to place 1/2 of the rootball below the existing riverbed and the end of the log several feet up the bank. This orientation encourages bottom scour at the rootball and in the middle of the channel during frequent flows (1 to 3-year return), which range from about 1,000 cfs to 3,000 cfs at this location.

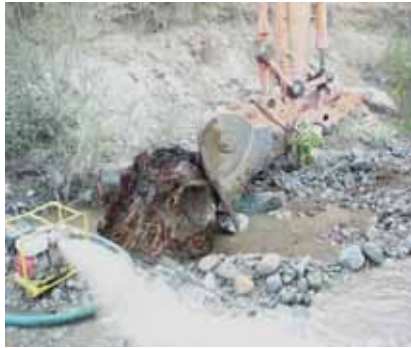
NUDGING the ROOTBALL into PLACE

The pump at the left is pumping about 250 gallons per minute or about 0.5 cfs. Channel bottom material was so coarse that water pumped out here infiltrated the alluvium approximately 300 feet downstream, before flowing back into the main stem.

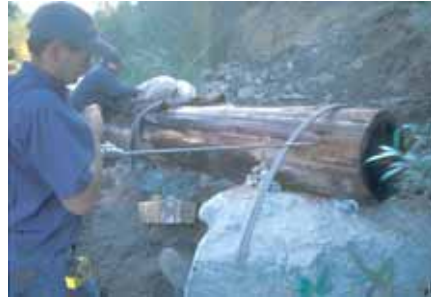
DRILLING HOLES FOR CABLING

Will Drew augurs through a redwood log. Cable is passed through the hole, around the log, through cable anchors glued into the boulder and clamped. Redundancy in the anchoring system (two cables per boulder) was a precaution made necessary by the potential cost of failure – one log loose in the river could cause a bridge washout or severe bank erosion.

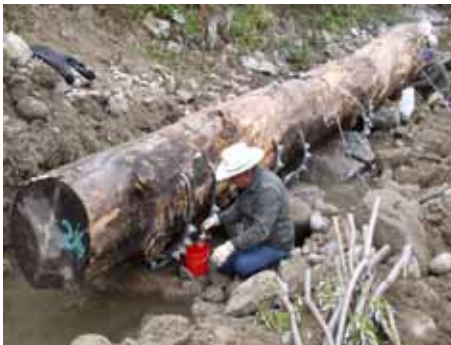
LOG CABLED IN PLACE

As indicated by the green point on the end of this log, the diameter is 2.25 feet. The largest diameter log was nearly 3.25 feet at the equivalent of breast height (the logs never were vertical during the project). Logs were anchored to boulders using eight 3/4-inch stainless steel cables (two per boulder). Willow cuttings at the lower right were placed behind the log prior to backfilling.

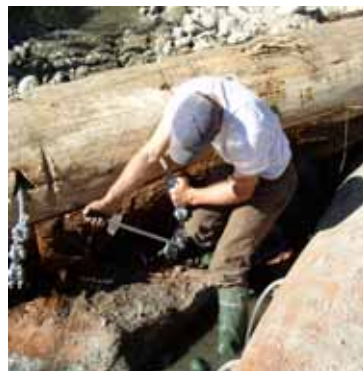
TIGHTENING CABLE CLAMPS

Will Drew checks the four 3/4-inch cable clamps placed on each cable. Torque was specified at 130 foot-pounds. Proper cabling was critical to the success of this project.

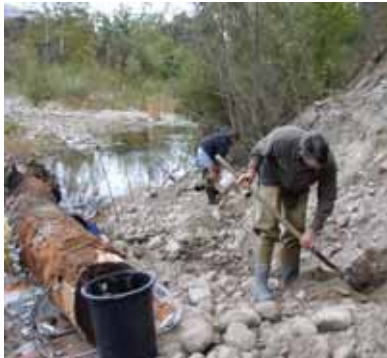
PLANTING NATIVE SEEDLINGS

Here, MPWMD river workers Matt Lyons and Mark Bekker plant gooseberry, sycamore, buckeye, and alder seedlings in areas disturbed by grading. Rains just one week after installation and close proximity to water mean that these plants, if they can survive winter flows in the first few years, are unlikely to need supplemental irrigation during the dry season.

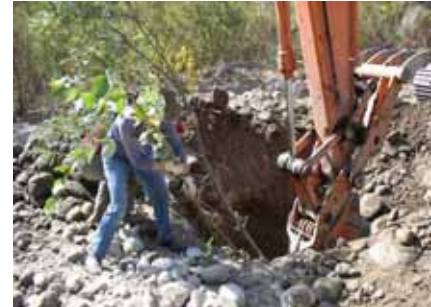
PLANTING CUTTINGS IN THE FLOODPLAIN

Digging a hole for a three-inch diameter willow or cottonwood cutting with a four-yard excavator bucket may seem like overkill, but the power of an excavator is needed to dig up the large cobble and boulders in the floodplain adjacent to the logs. The largest particle dug up during this project was in the one-ton range. Even a large backhoe with a three-foot wide bucket is not as effective as this excavator. Note the depth of the hole (about five feet), which allows the cuttings access to water year-round.

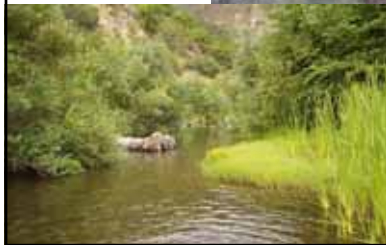
August 18, 2005
(left)

Work was completed one day before expiration of the permits on November 1, 2002. One week later, 10 inches of rain fell in the upper watershed, causing the river to flow at 400 cfs through this site.

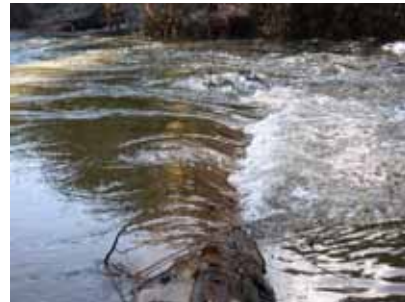
WINTER SCOURING ACTION

Here, flow of 500 cfs is moving from left to right and scouring the channel bottom near the rootball (upper center of photo) and under the log. A hydraulic jump can be seen on the downstream side of the log. At higher flows, the jump is drowned out and becomes a standing wave. Controlled energy dissipation is important in this reach, where chronic bank erosion threatens structures downstream, close to the banks.

MPWMD plans to resurvey the channel bottom during the summer of 2003 to document scouring effects.
