A case study on desert tortoise (*Gopherus agassizii*)

Project description and location

- Add an additional lane on both sides of Interstate 15 and widen shoulders on a 21 mile stretch of the freeway between Barstow and Victorville in San Bernardino County.
- The project will permanently impact 74 Acres of desert tortoise habitat, as well as, 61 Acres of temporary impacts.

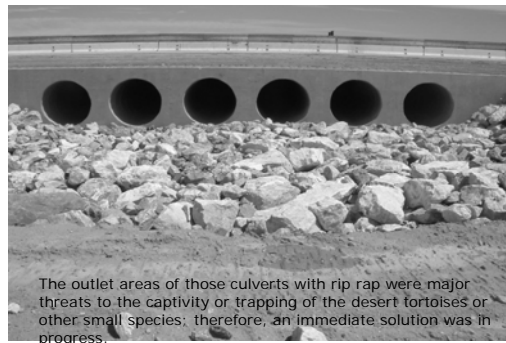
The outlet areas of those culverts with rip rap were major threats to the captivity or trapping of the desert tortoises or other small species; therefore, an immediate solution was in progress.

- Caltrans Monitors identified and evaluated the potential culverts. A request to amend the contract to make proper changes (Change Order) was recommended to the Project Resident Engineer to correct the rip rap problem by placing gravel in all rip rap.
- Because of a smaller population density south of Dale Evens (PM 51.8), it was agreed to provide accessibility south of Dale Evens for the desert tortoise only on a ½ mile basis.
- And based on the formula, a total of 94 culverts had to become accessible by gravel placement.

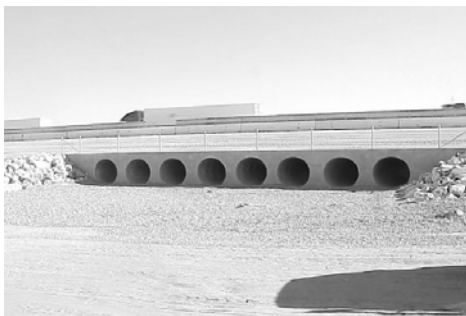
Finally it was agreed and decided among Caltrans, CDFG, and USFWS to place gravel within the rip raps of those culverts that had created a major threat.
