Publication No. WI-2014-14  
16 December 2014

### **The Watershed Institute**

## **Spatial and Temporal Variations in Streamflow and Water Quality – The Reclamation Ditch and Tembladero Slough, Monterey County, California**

CSUMB ENV5 660 Class:

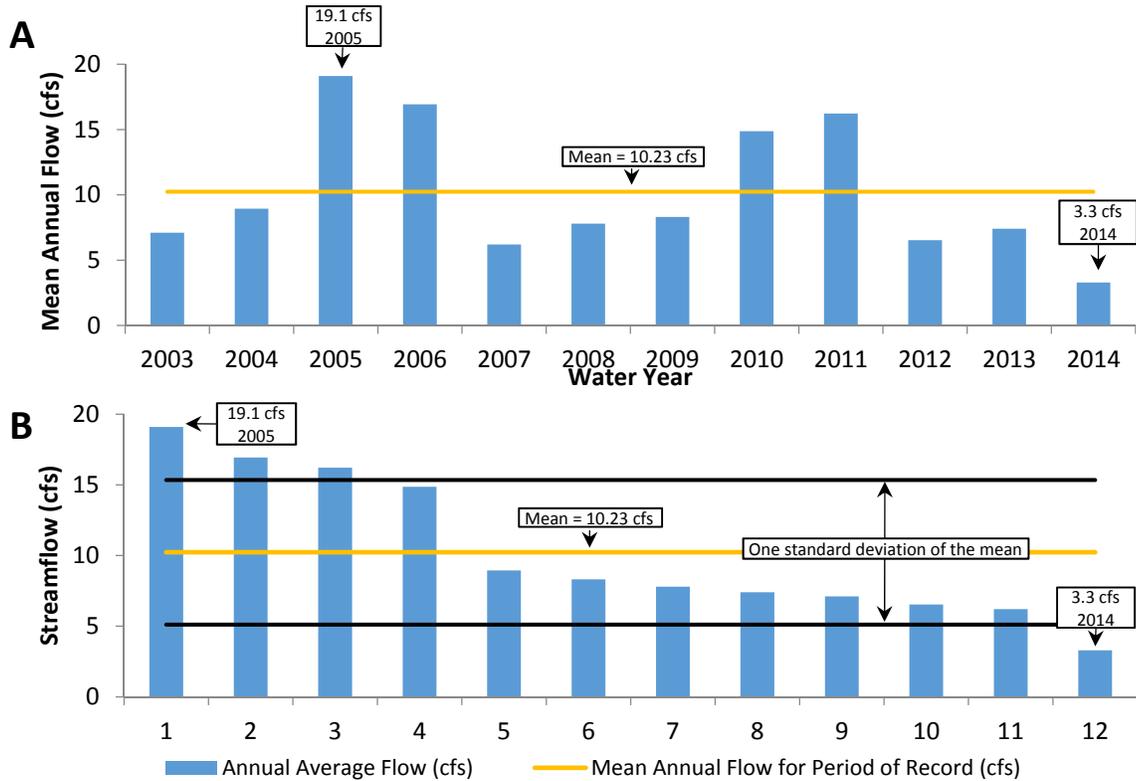
**Figure 9: Mean annual flow for the USGS San Jon Rd. gage at (A) the Reclamation Ditch: by Water Year 2003 - 2014, and (B) ranked by Water Year 2003 -2014.**

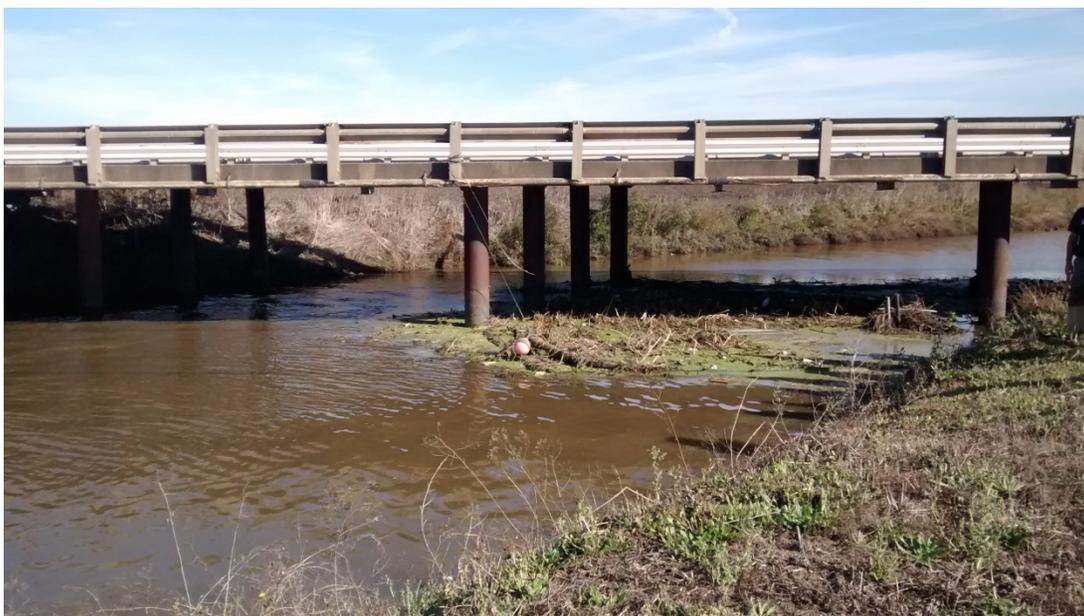
Figure C2: Molera Rd. sample site. Water quality measurements were taken by lowering the YSI from the bridge into the water on the left side of the image.

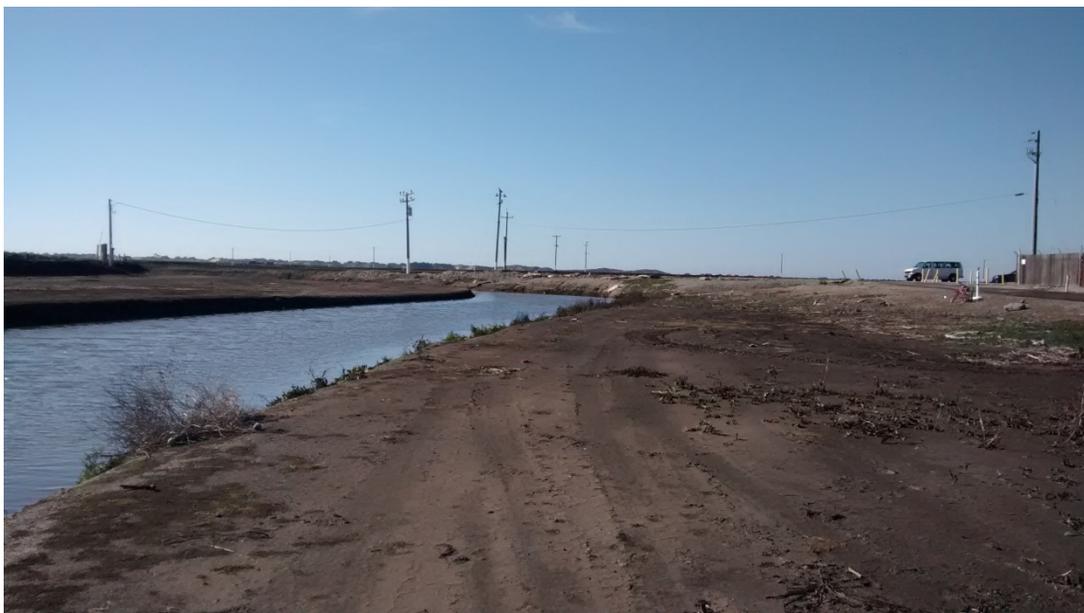
Figure C4: Castroville Intake sample site.

Figure C3: Map for the Castroville Intake sample site. Water quality measurements at the Castroville site were taken from the bank. We observed that at this location the slough had a trapezoidal cross section with a flat uniform bottom with no obvious thalweg for taking measurements. The lack of a stable structure to take consistent depth measurements prevented us from collecting streamflow data.

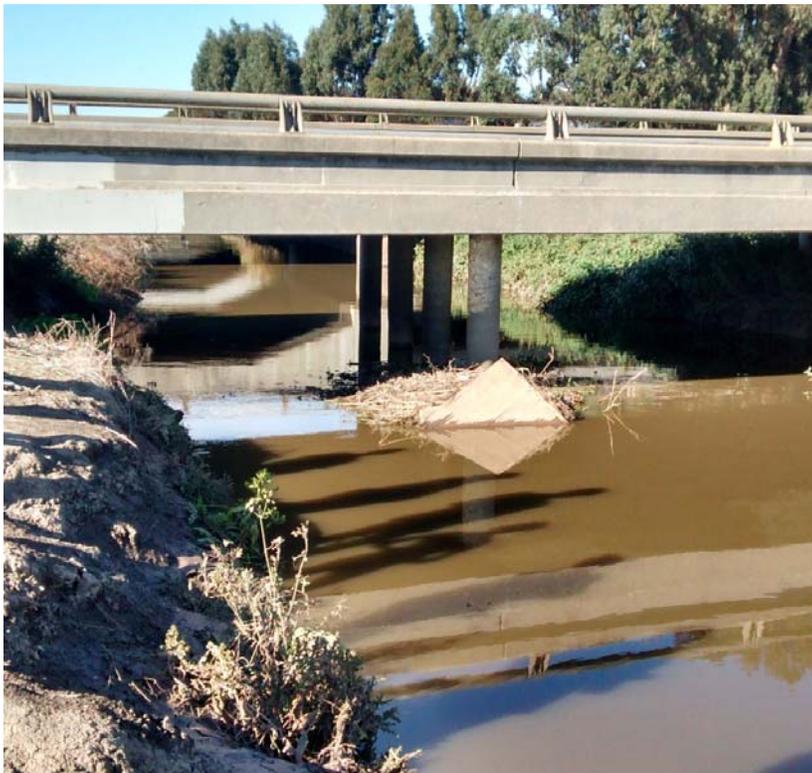
Figure C6: Haro St. bridge at the Haro St. sample site. Depth measurements were taken from the bridge at the second visible railing support from the left edge of the image.

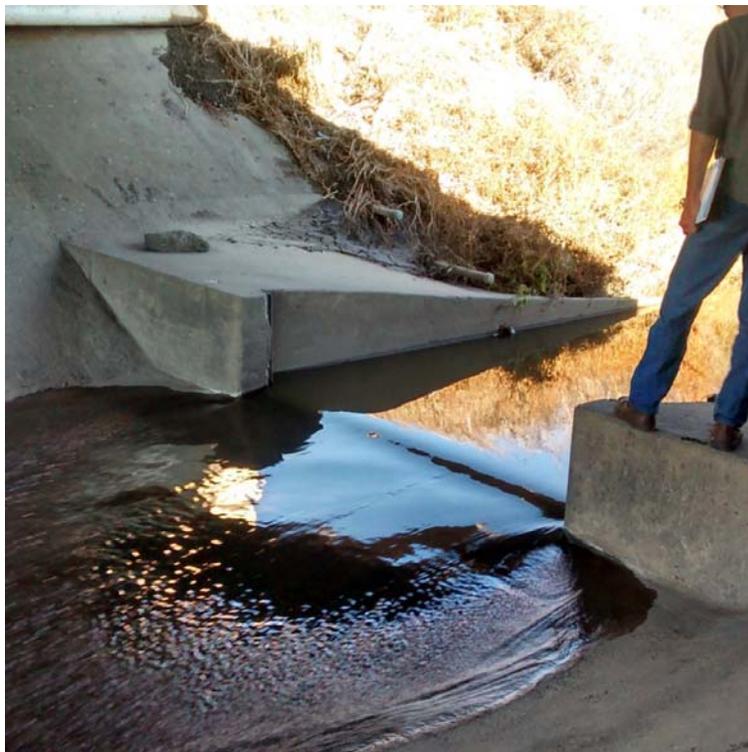
Figure C8: The San Jon Rd. sample site. The upstream measurements were taken upstream of the concrete channel apron.

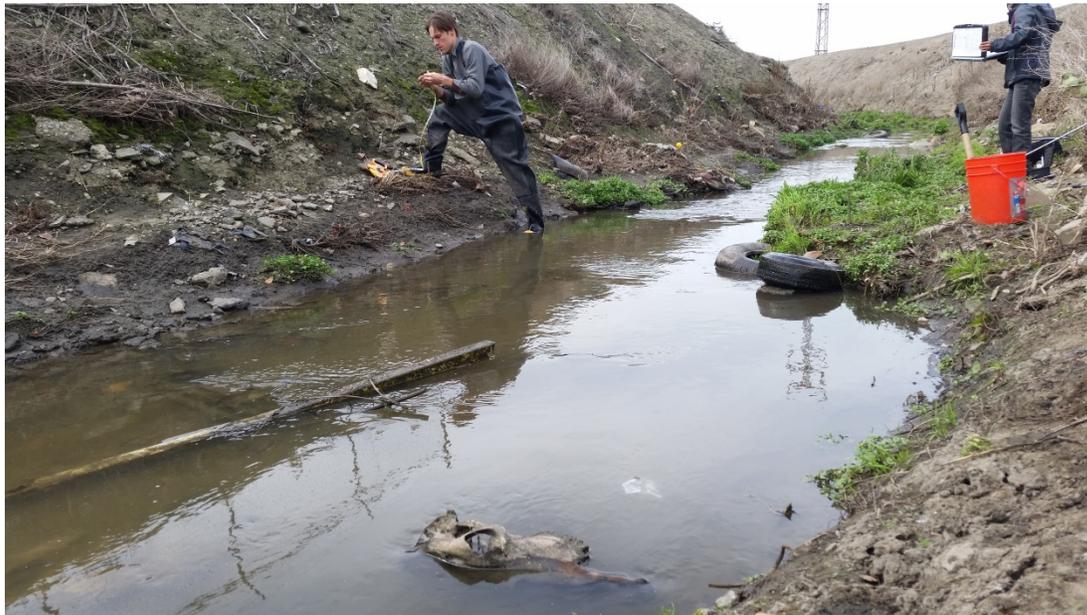
Figure C10: Preparation for pygmy meter measurements at the Boronda St. sample site. We made some minor bank alterations to improve the quality of the pygmy measurements.

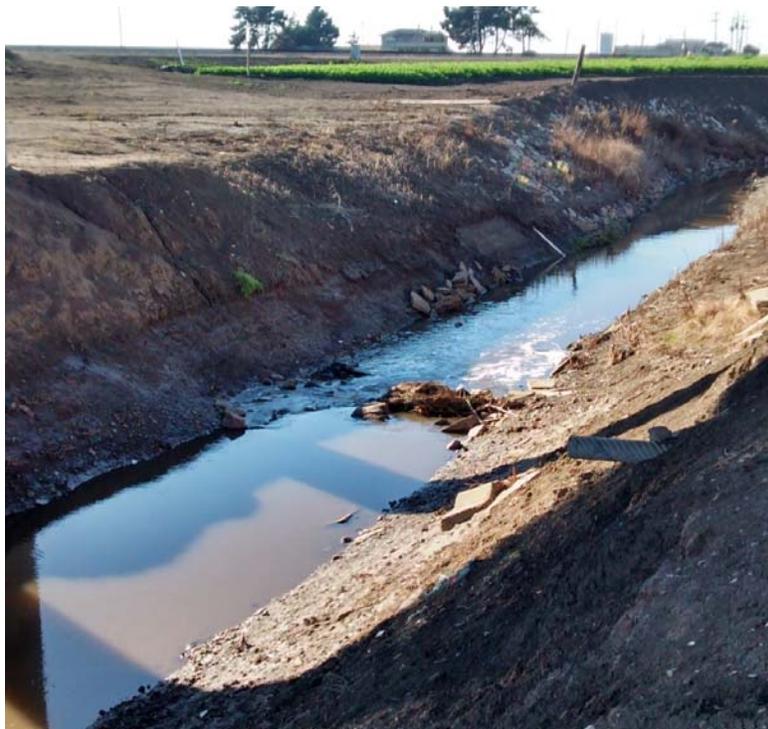
Figure C12: The Davis Rd. sample site. The hydraulic jump that separates the water quality and flow measurements was created by debris in the water channel.

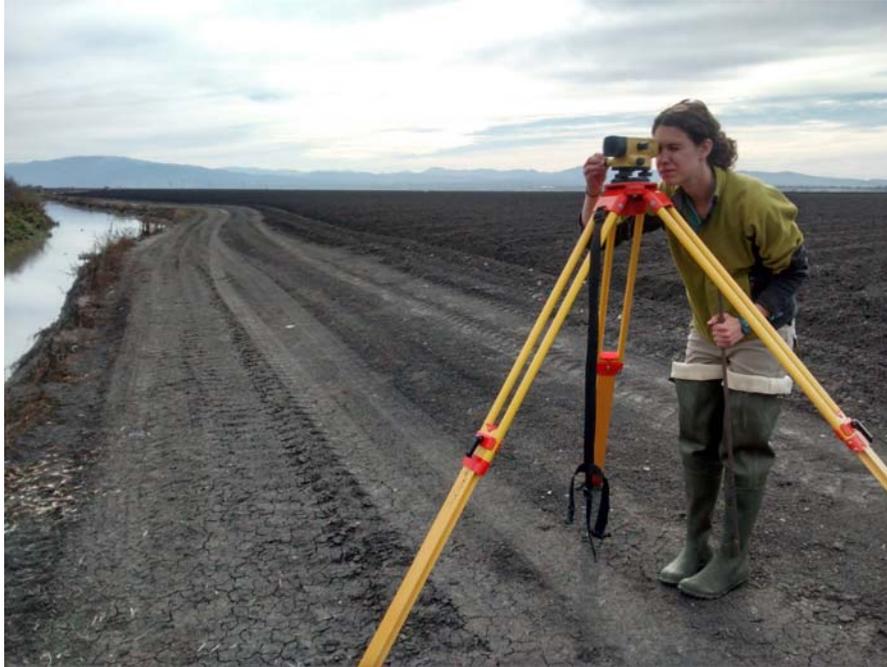
**Figure D1:** We used an auto level to measure the cross-section at the Haro St. and Molera Rd. sample sites. This photo was taken at the Haro St. site, upstream of the bridge.

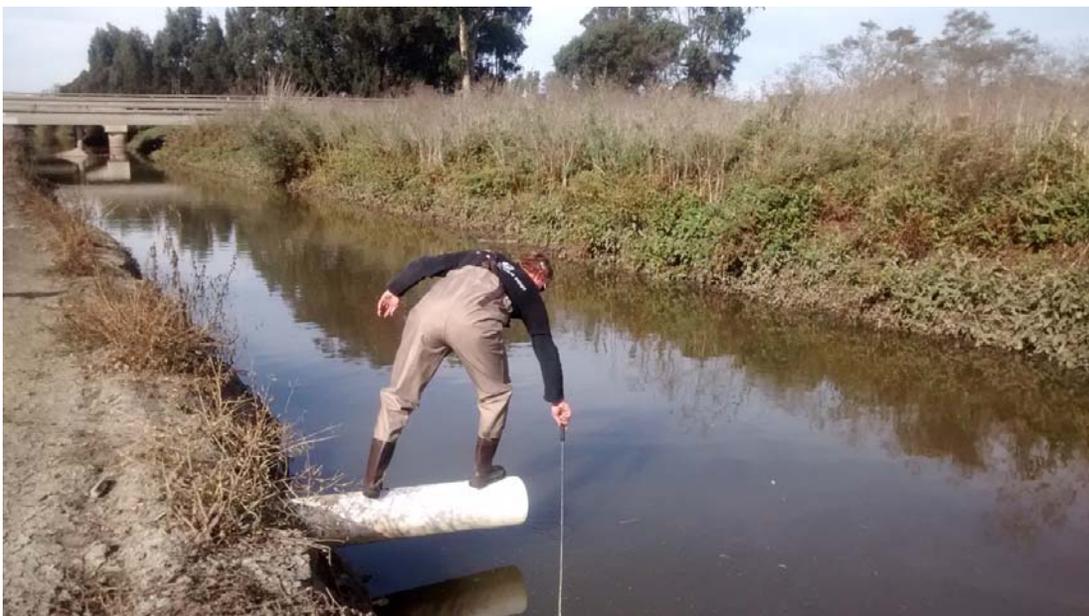
**Figure D2:** At the Haro St. sample site we collected the turbidity sample off of the end of a drainage pipe to get access to the mid-channel water.

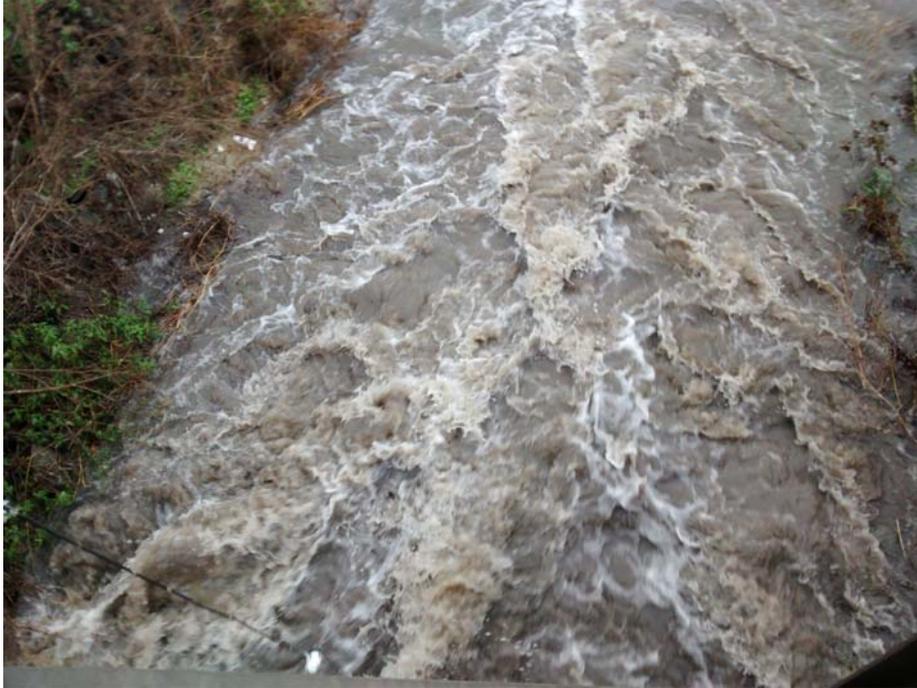
**Figure D3: The San Jon Rd. sample site during the high flow event on December 2<sup>nd</sup>. The YSI is visible in the left hand of the image. We had difficulty fully submerging the YSI on this day because of the velocity of the water.**

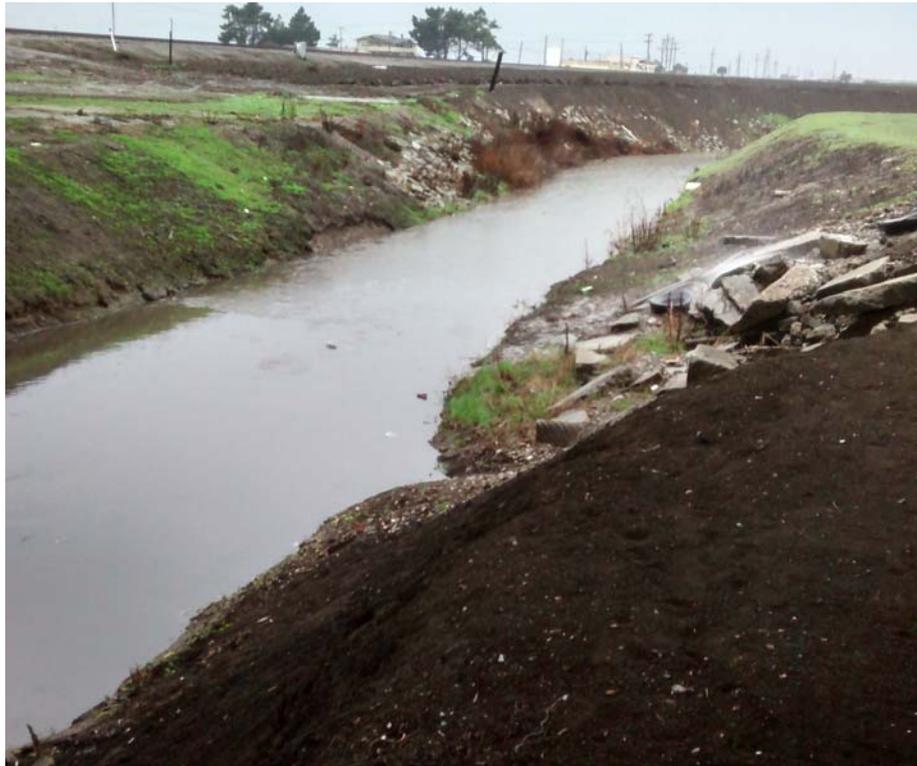
**Figure D4: The Davis Rd. sample site during the high flow on December 2<sup>nd</sup>.**
